AFAPL-TR-76-58

# LIFE TEST OF A DYNAVECTOR ROTARY ACTUATOR FOR AIRCRAFT HYDRAULIC SYSTEMS

OCTOBER 1976

TECHNICAL REPORT AFAPL-TR-76-58  
FINAL REPORT FOR PERIOD JULY 1971 Thru MARCH 1976

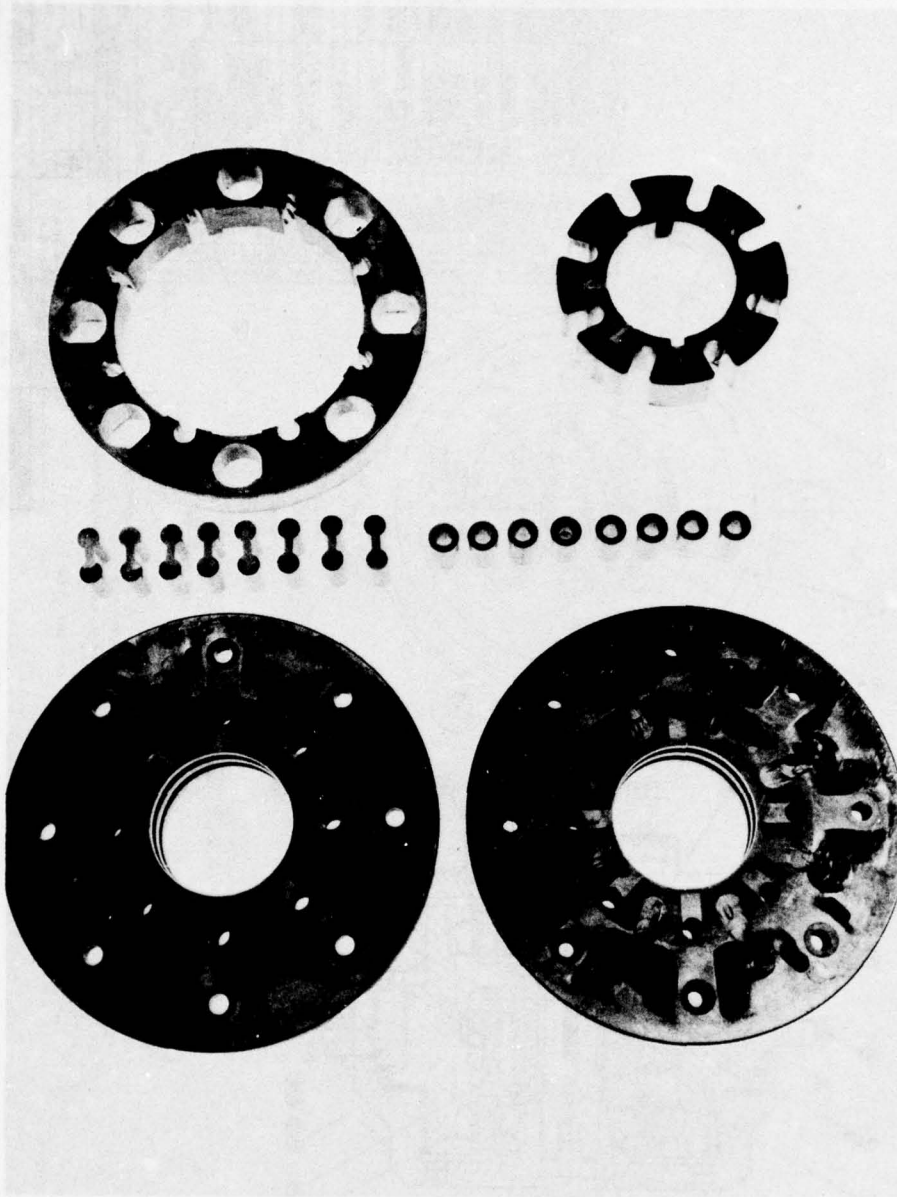
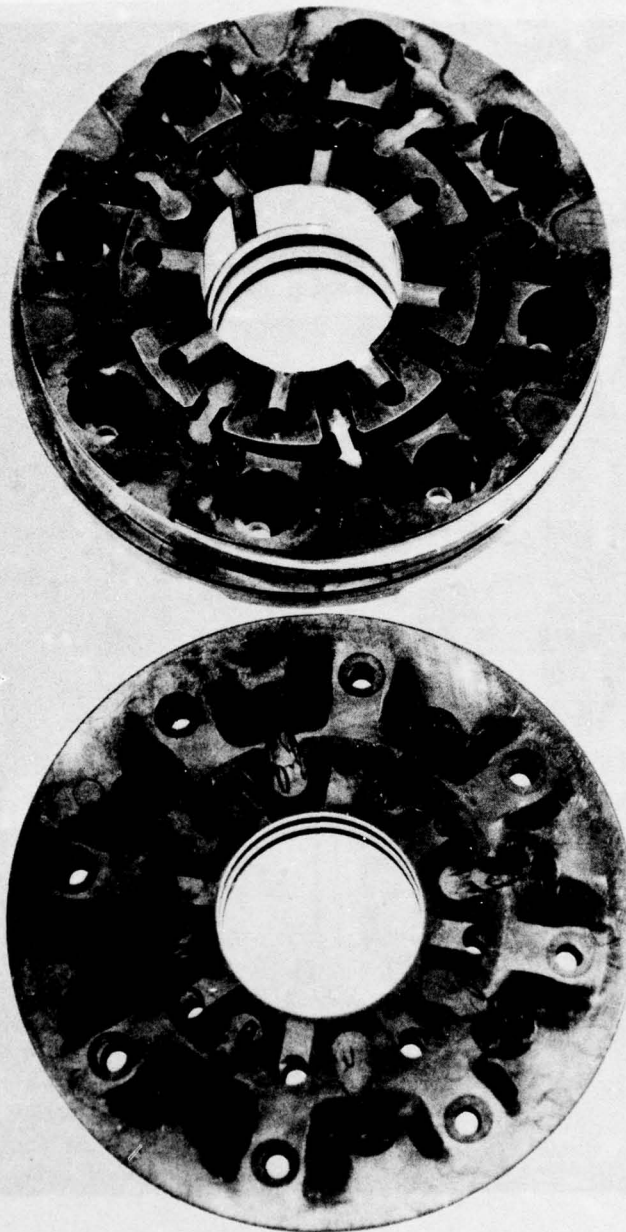
f. Motor - No sign of significant wear was found on any of the motor parts as shown in Photos 2 and 3.

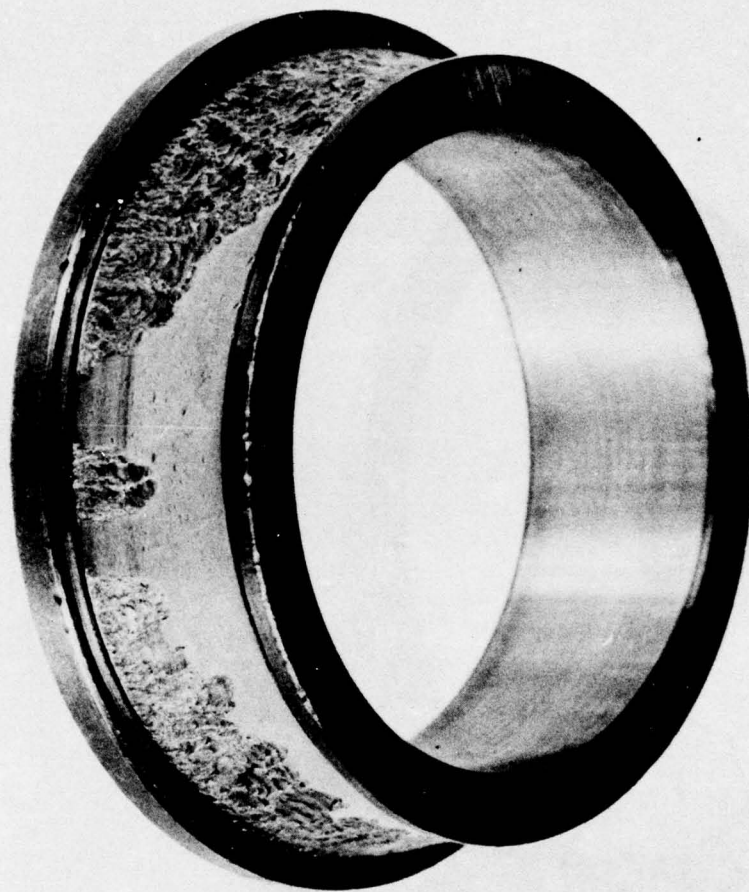
The actuator was then installed in the test system with an aircraft-type piston pump and an electro-hydraulic servo valve. This system is described in Section III. The actuator was cycled at a rate of 24 cycles/min from 50,000 in-lb in one direction to 50,000 in-lb in the other direction and return for 50,000 cycles. This corresponded to  $\pm 7.5^\circ$  of rotation of the actuator. The cycle rate was then reduced to 12 cycles per minute and the load increased to 100,000 in-lb. This corresponded to  $\pm 15^\circ$  of rotation. After 3400 cycles the actuator became extremely erratic. Disassembly revealed failure of a tapered roller bearing (TIMKEN #29586 cone and #29522 cup) that was in the upper part of the actuator (see Figures 11 and 12). A similar bearing in the lower part indicated some distress but not as severe damage. Based on contact with both Bendix and Timken, it was determined that the probable cause of failure was improper preload of the bearing during assembly. The remainder of the actuator was in good condition.

Figure 11. Failed Timken Bearing After Run No. 2

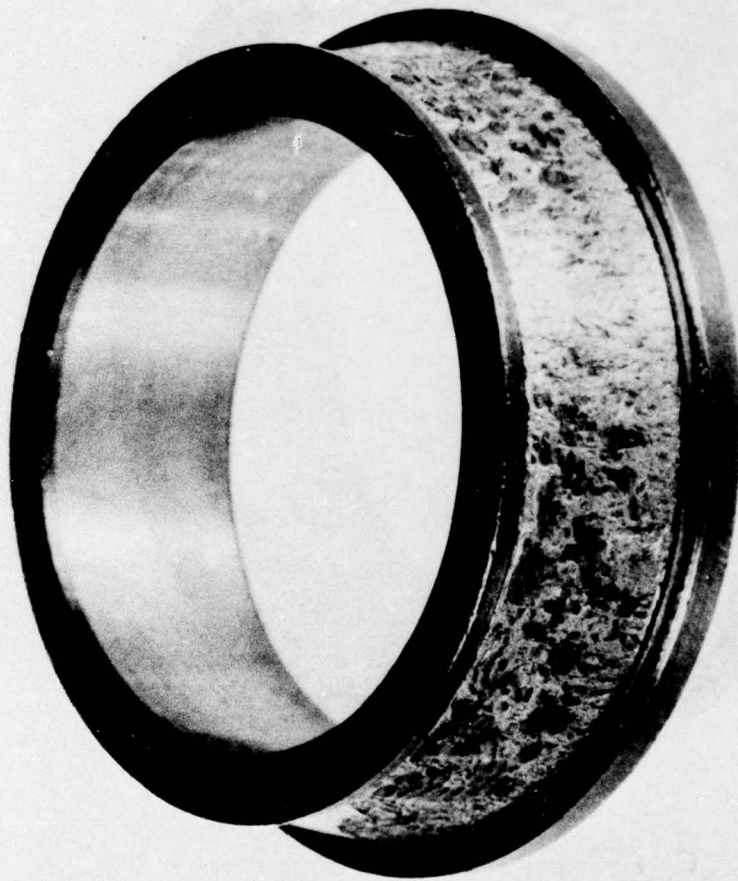
Figure 12. Failed Timken Bearing After Run No. 2

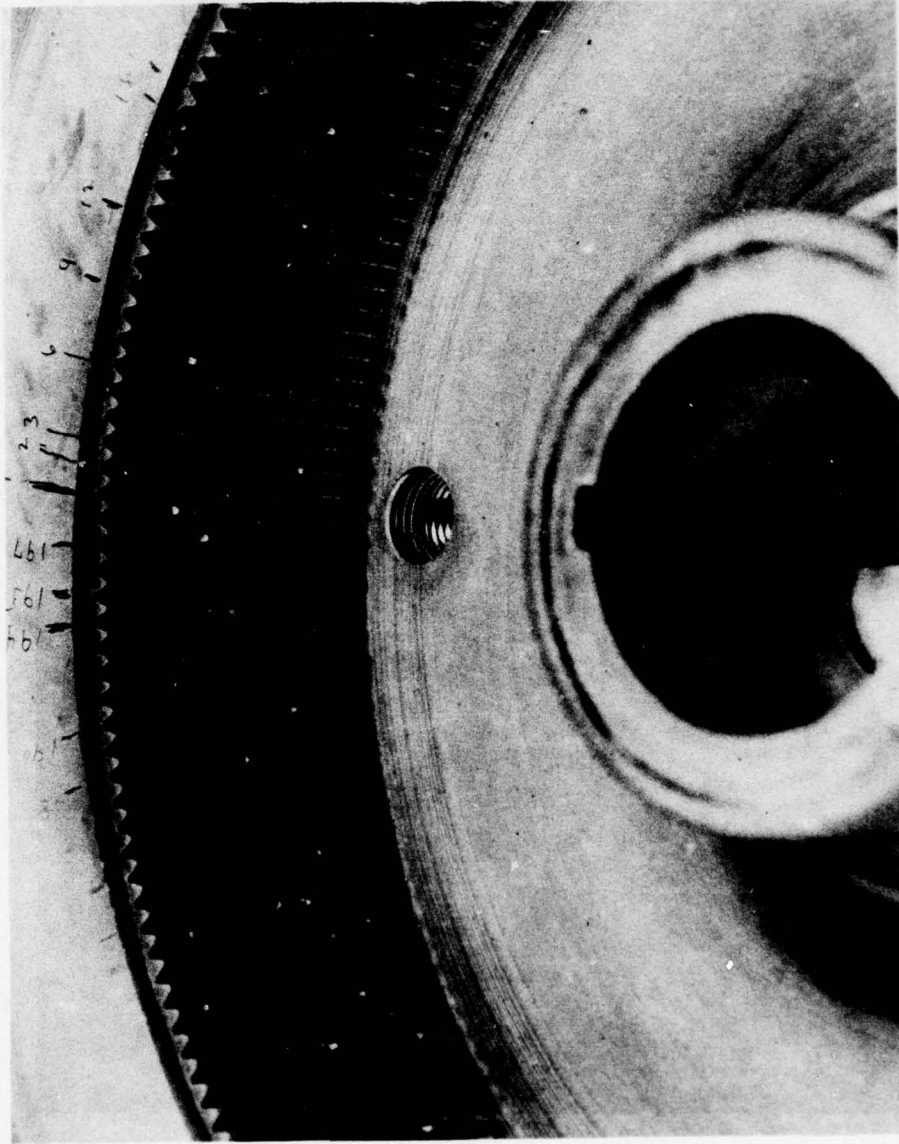
was provided to the bearings. A magnetic pickup was installed in the case drain line to indicate failure of the actuator. The testing was then resumed with the same test cycle as conducted in runs 2 and 3. After 68,000 cycles at  $\pm 50$  in-lb load, chips were found in the magnetic pickup. Again testing was stopped and the actuator disassembled. The Timken bearings were in good condition. The chips were now coming primarily from the lower ground gear. The debris from the previous bearing failure had resulted in distress to this gear and the load was then causing chipping of the gear teeth in the areas of distress. Figures 13 thru 15 show the gears after this test. As can be seen from the photos shown in Figures 16 thru 18, the lower gears indicate the most damage. This further substantiates the premise that the bearing failure debris initiated the chipping of the gear teeth. A photo (Figure 19) of the ring gear and of the output gear (Figure 20) taken after this test indicates some signs of debris but no chipping of gear teeth.

Figure 13. Lower Ground Gear After Run No. 4 (Teeth No. 70 Thru No. 20)

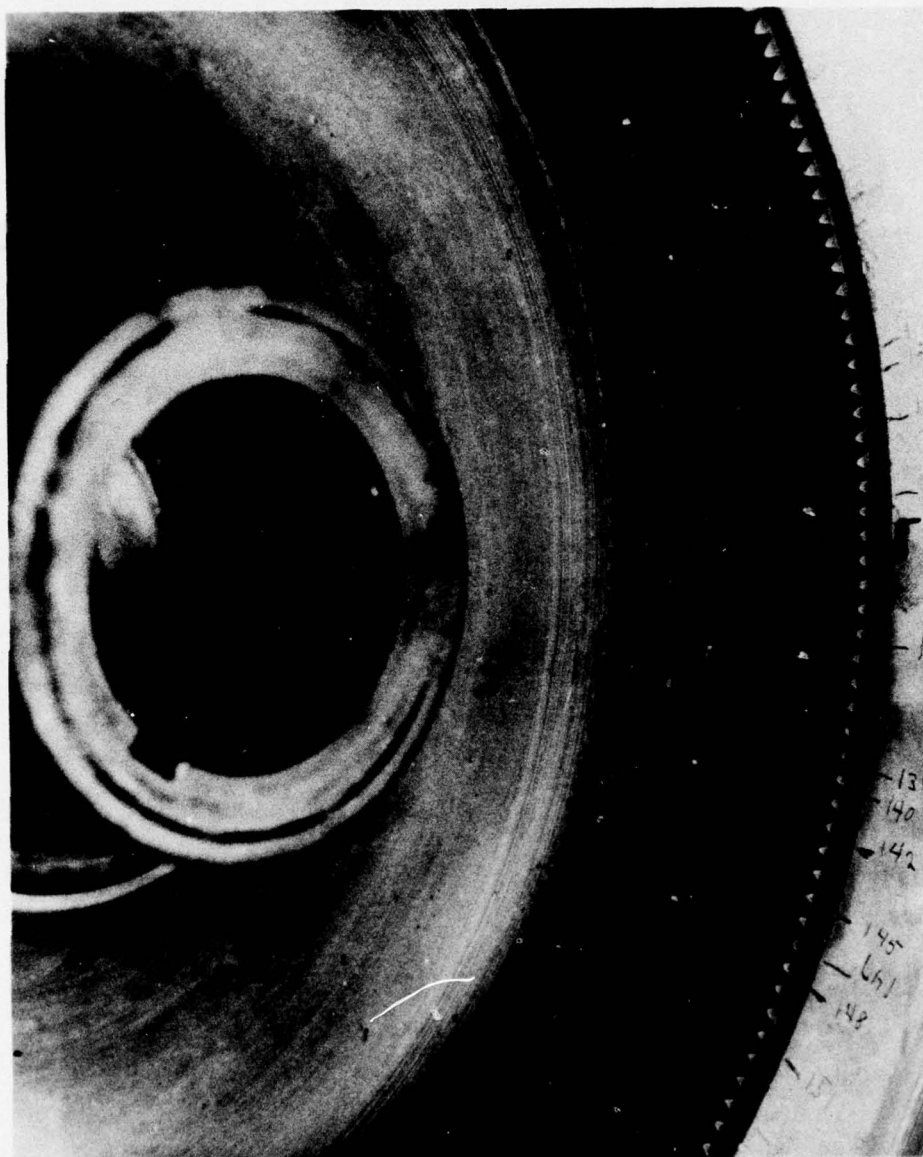
Figure 14. Lower Ground Gear After Run No. 4 (Teeth from Approx No. 110 Thru No. 155)

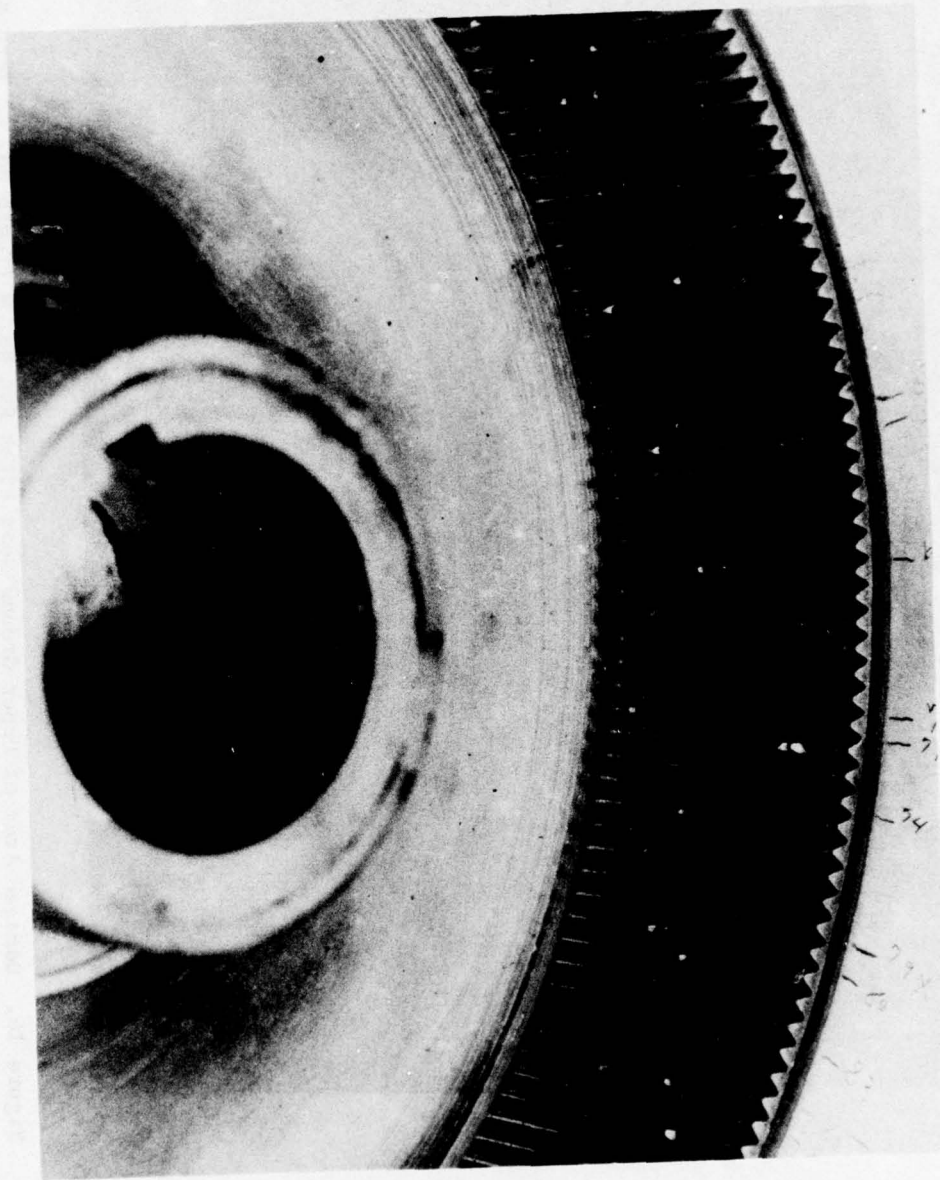
Figure 15. Lower Ground Gear After Run No. 4 (Teeth No. 40 Thru No. 88)

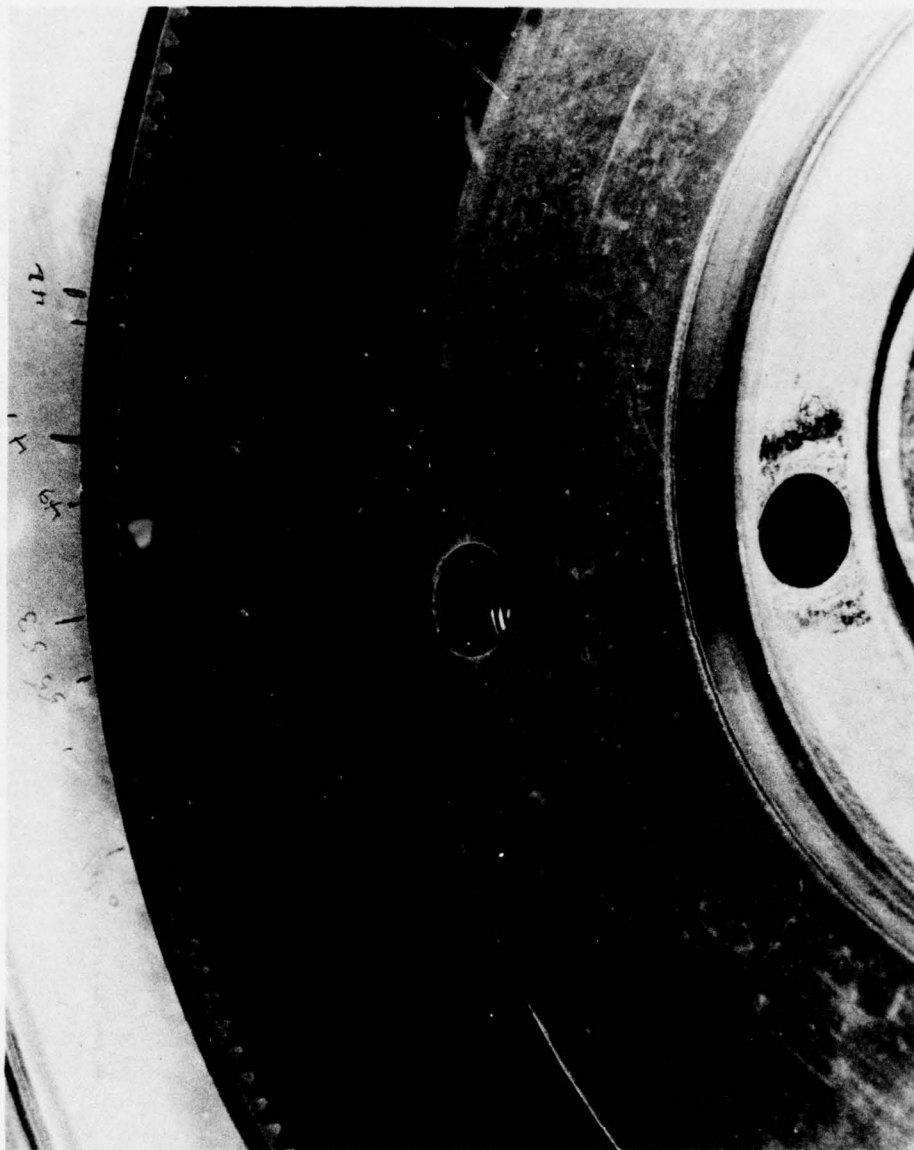
Figure 16. Damaged Area of Upper Ground Gear After Run No. 4 (Teeth No. 42 Thru No. 55)

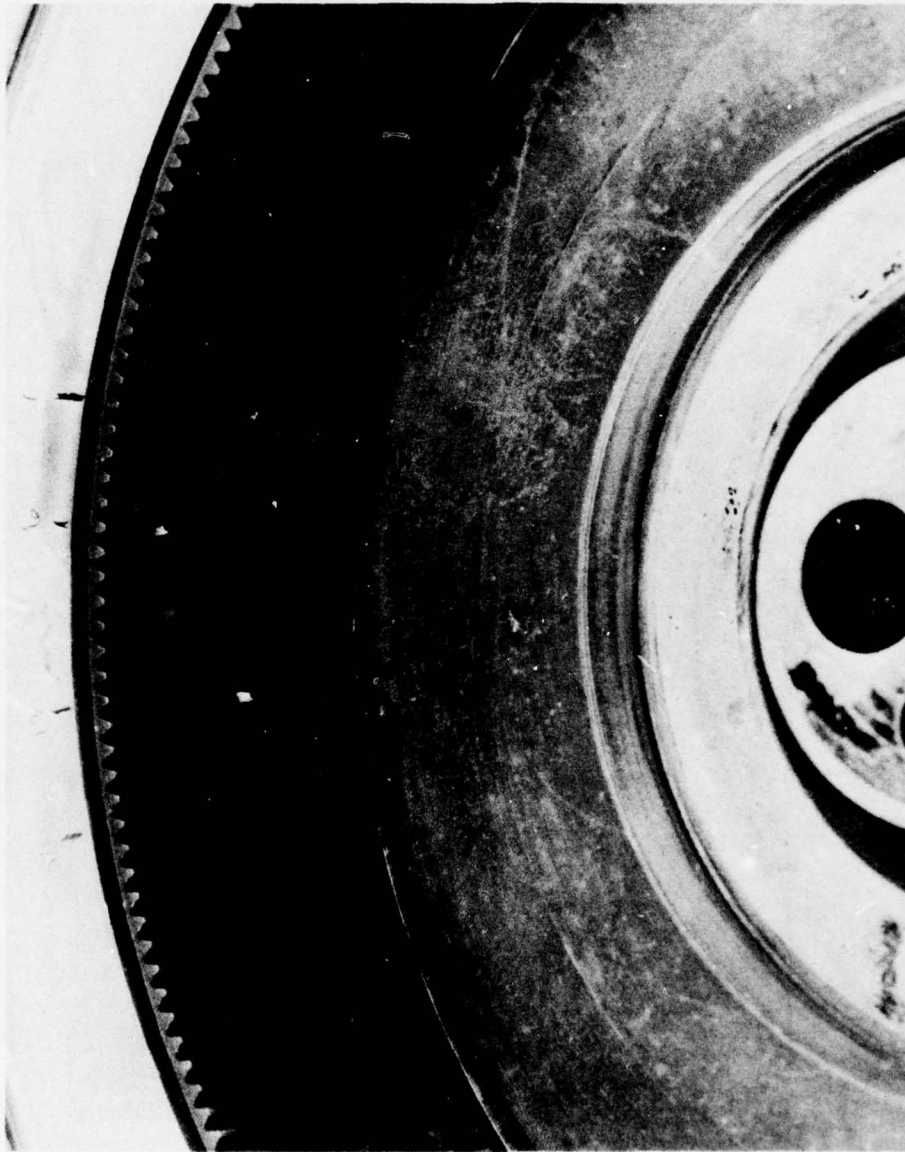
Figure 18. Damage to Teeth No. 1, 6, and 13 of Upper Ground Gear After Run No. 4

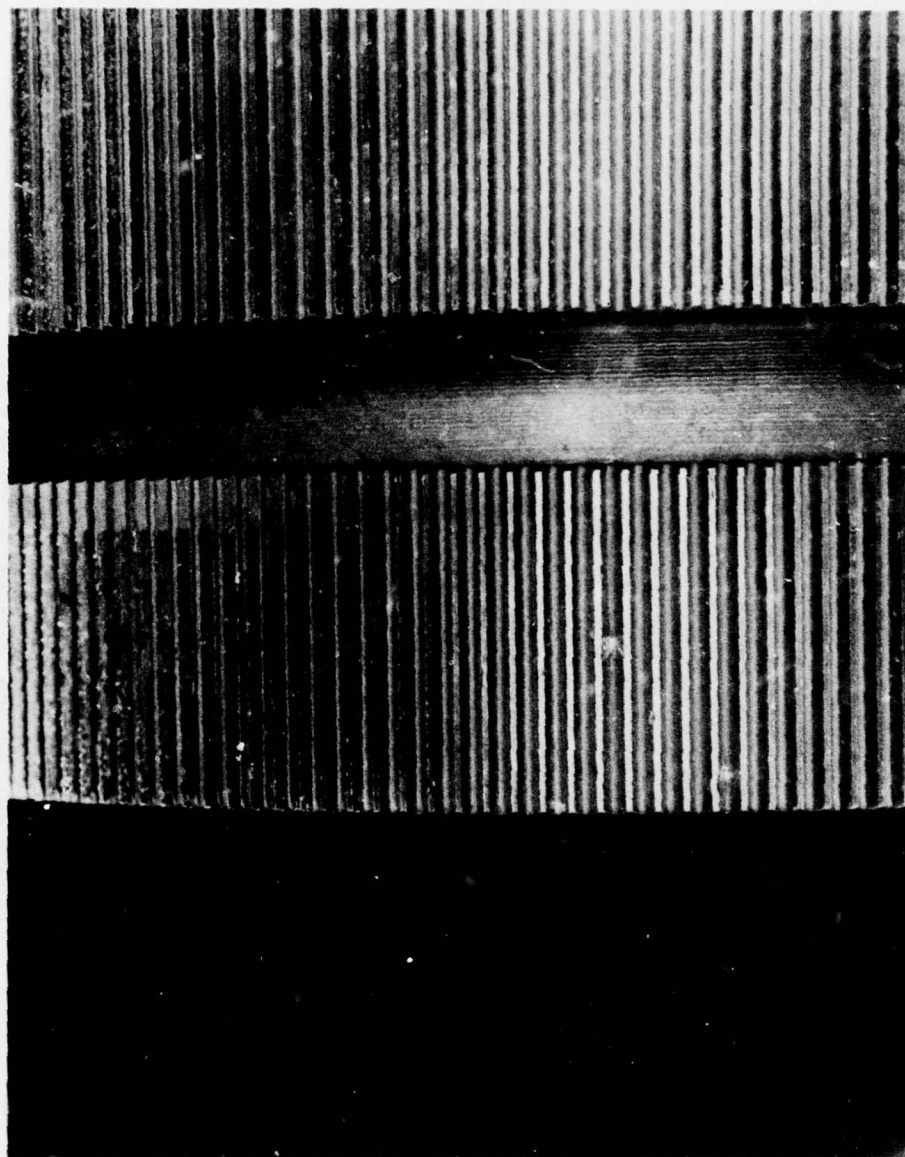
Figure 19. Ring Gear After Run No. 4

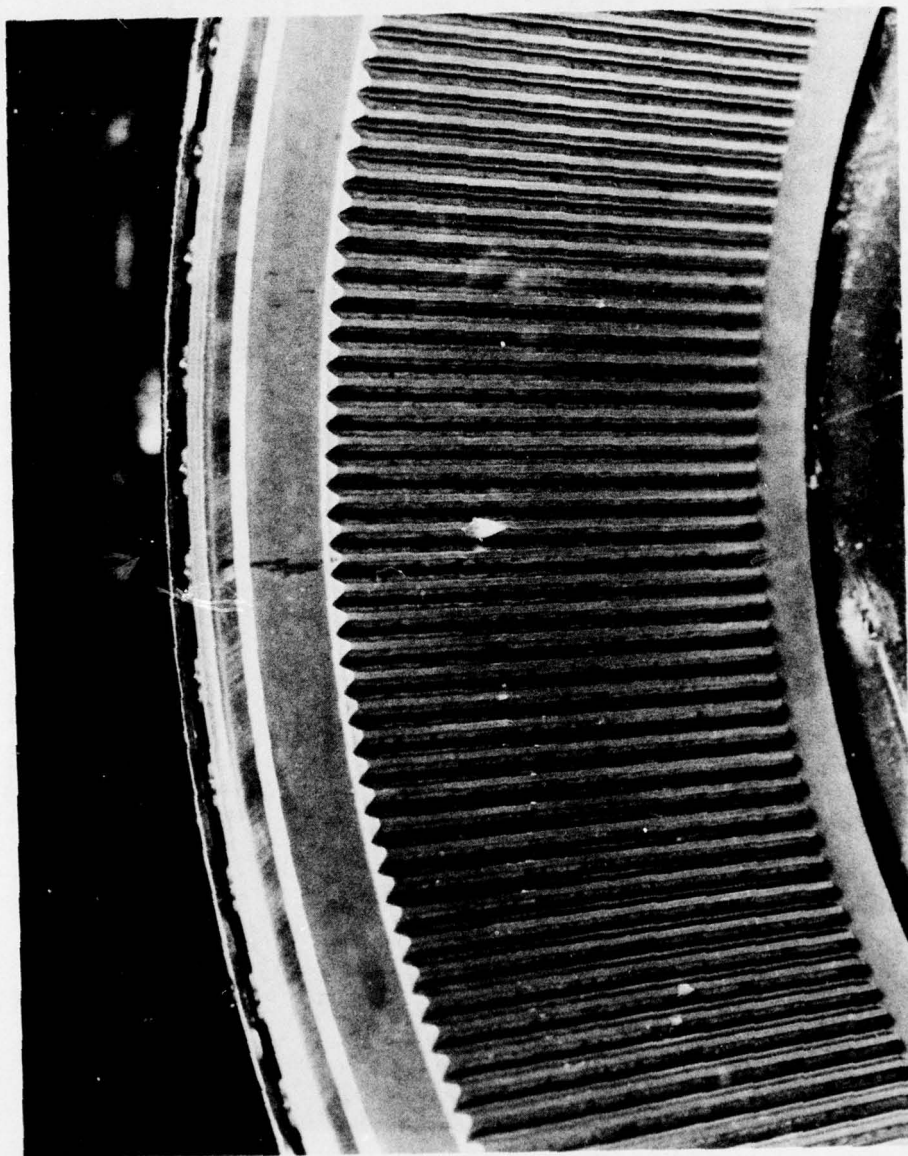
Figure 20. Output Gear After Run No. 4

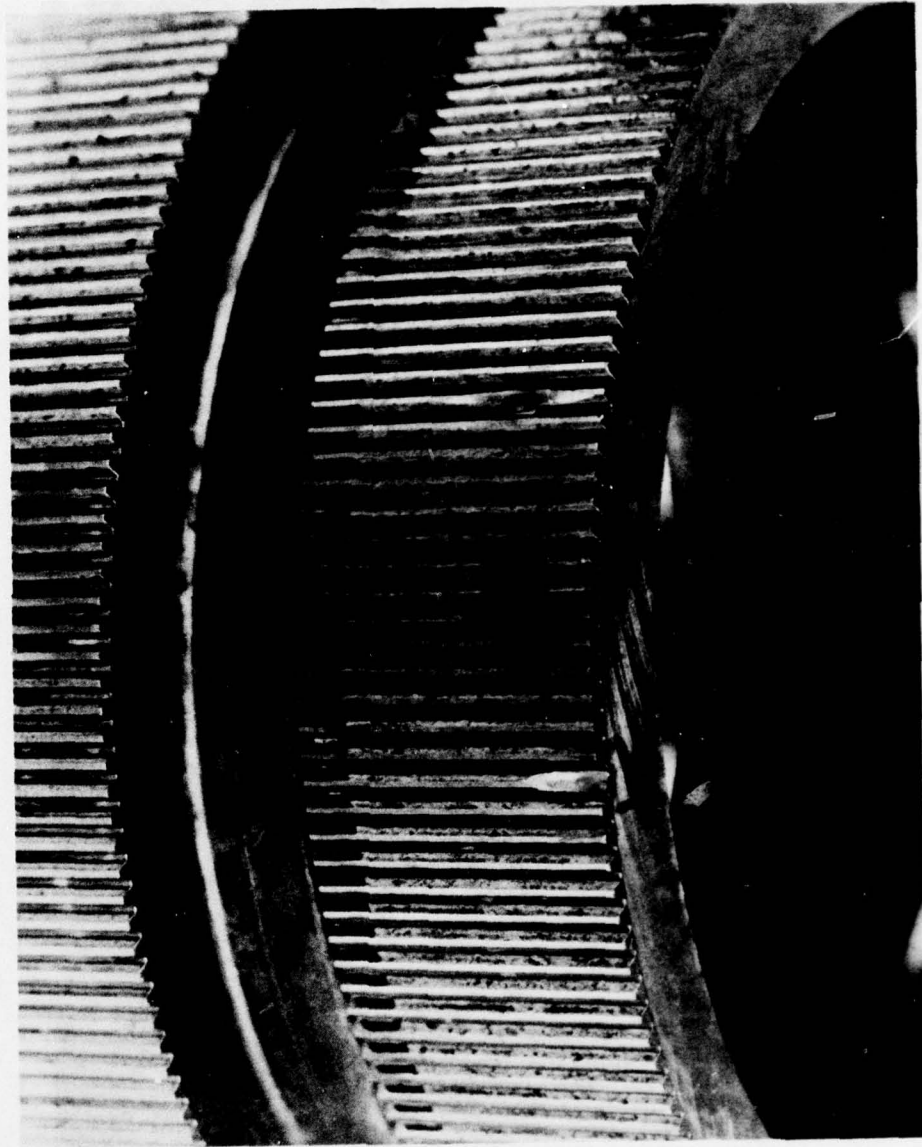
a. Ring gear, Bendix Part #2175530 - The gear teeth that mesh with the lower ground gear had five pieces of teeth missing as shown in Figures 21 and 22. The teeth with missing pieces as shown in Figure 22 are separated by six teeth or a multiple thereof. Since there is a six-tooth difference between the ring gear and ground gear, this indicates that a piece of tooth must have lodged itself onto one of the teeth and caused other teeth failures when the gears were in mesh. Other teeth that were a multiple of six teeth away from the failed teeth also had deformation to indicate this contact. In fact, a similar piece of tooth (see Figure 22 for location) was removed by applying light pressure with a scriber.

Figure 21. Ring Gear After Run No. 6 (Lower Gear)

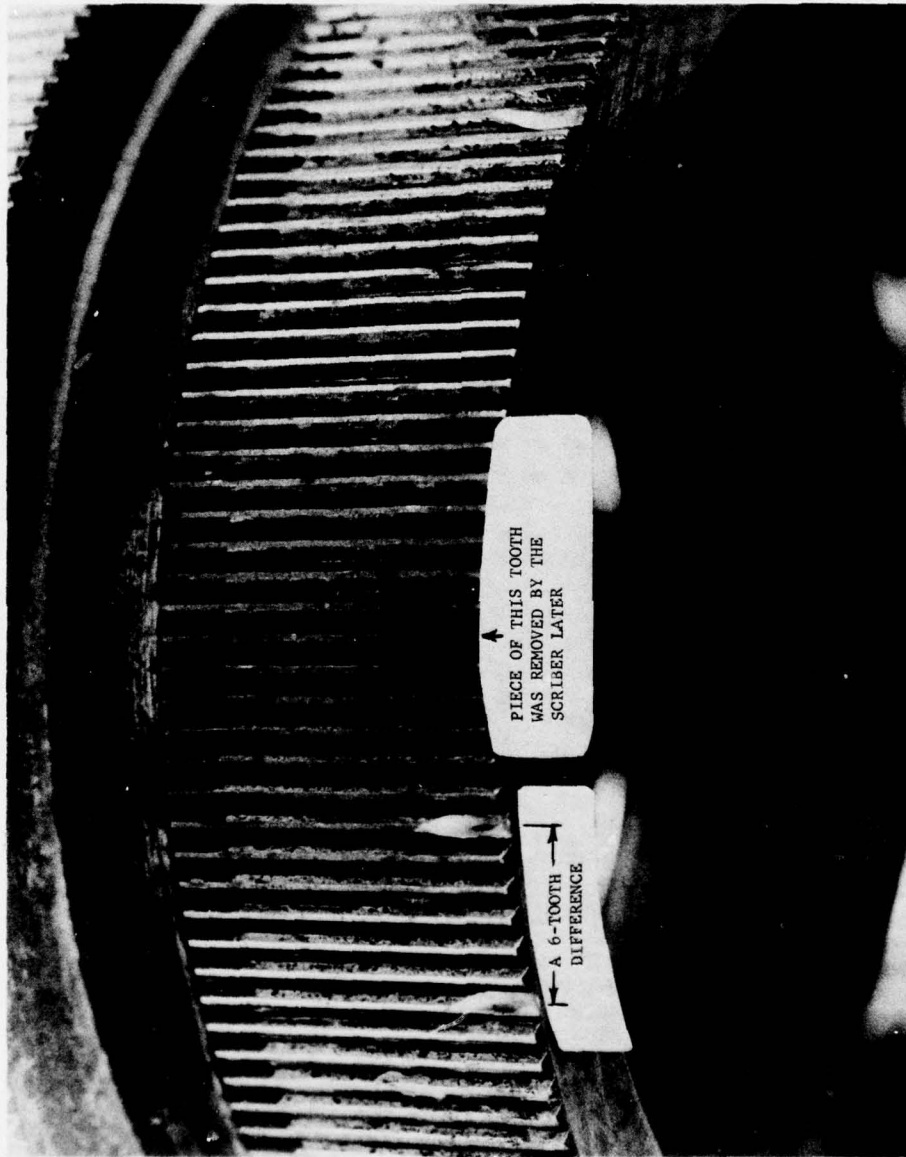
Figure 22. Ring Gear Teeth Damage After Run No. 6 (Lower Gear)

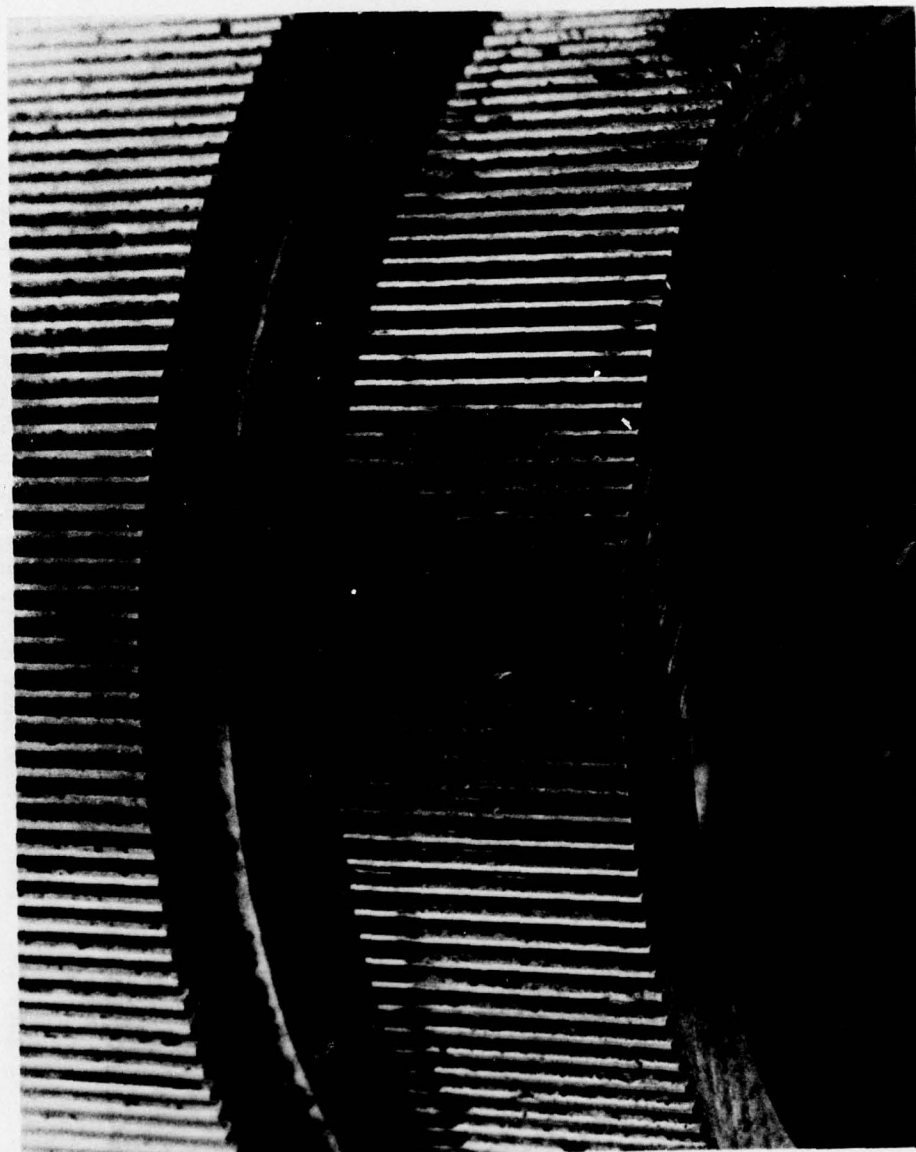
The gears (see Figure 23) that engage the upper ground gear and the output gear had not experienced any significant damage since the last inspection after run number 4.

Figure 23. Upper Portion of Ring Gear After Run No. 6

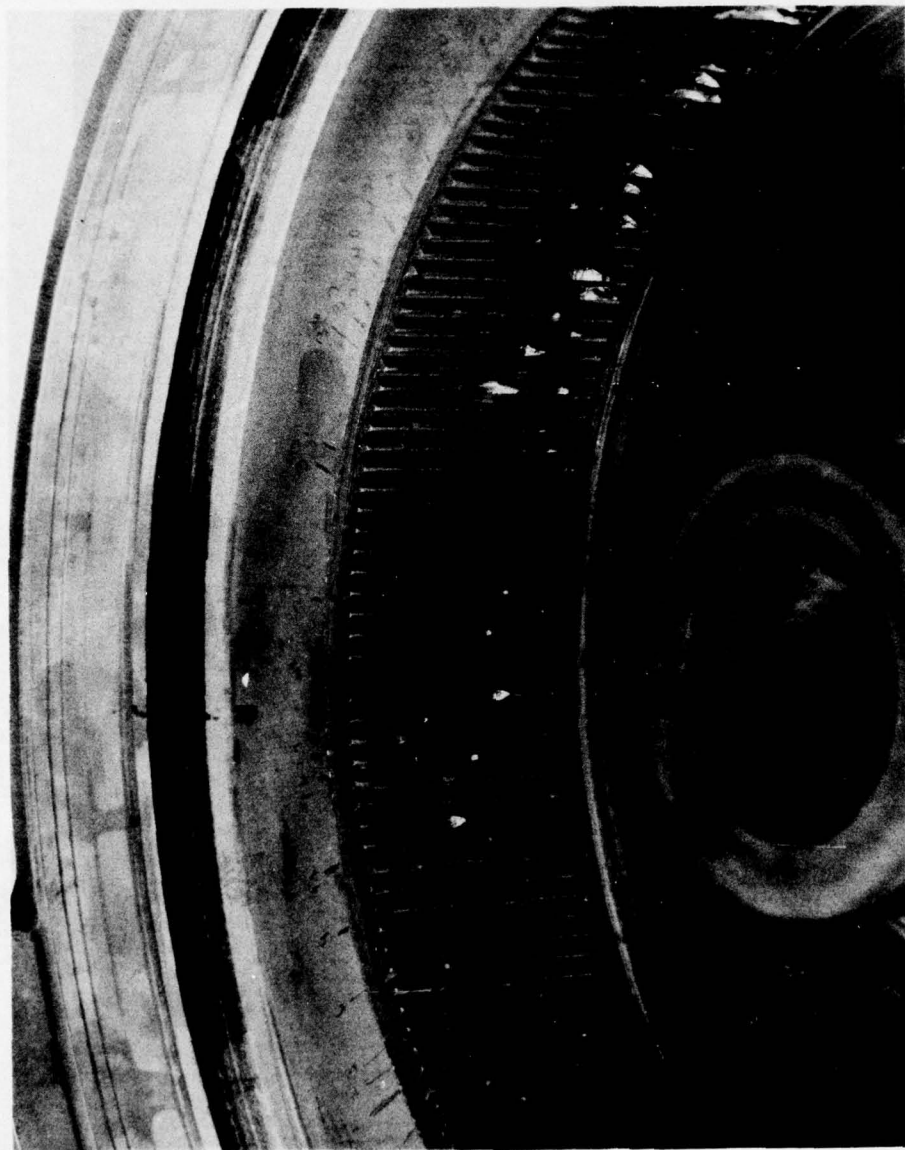
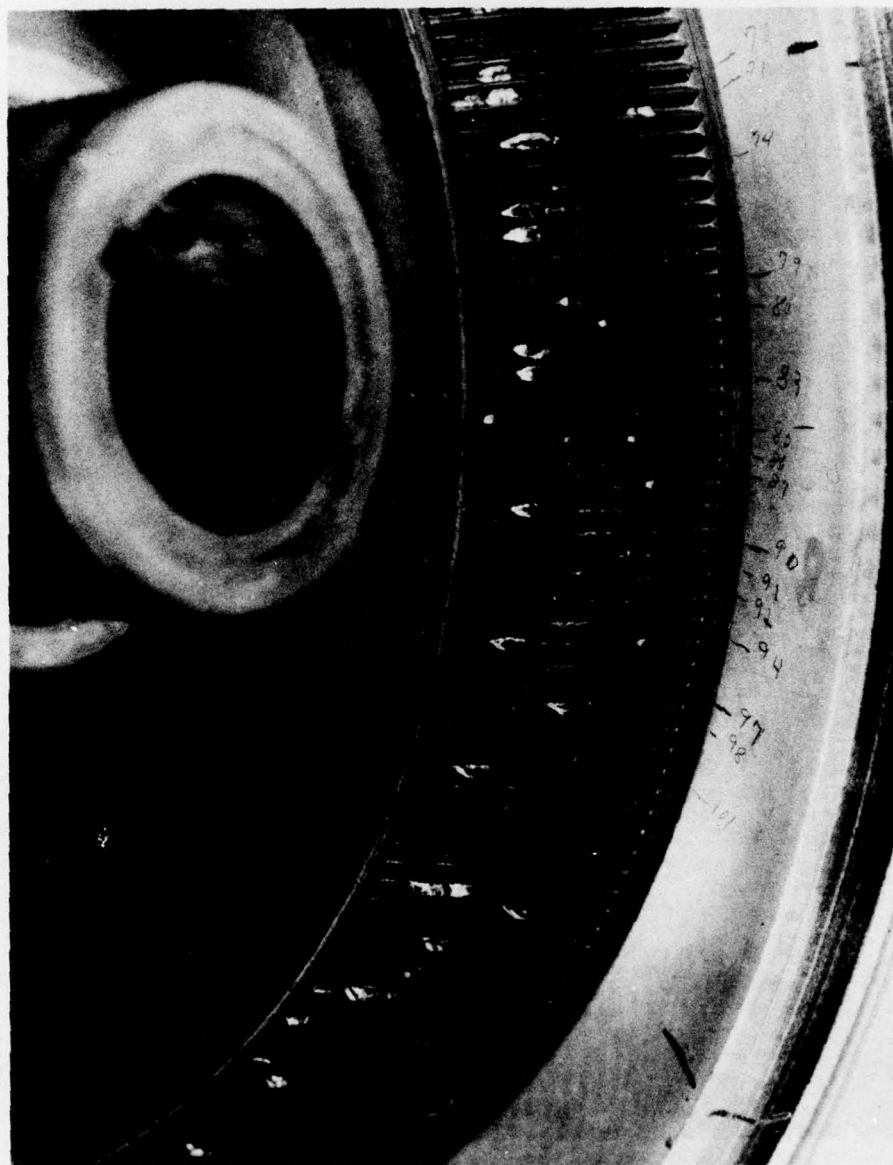
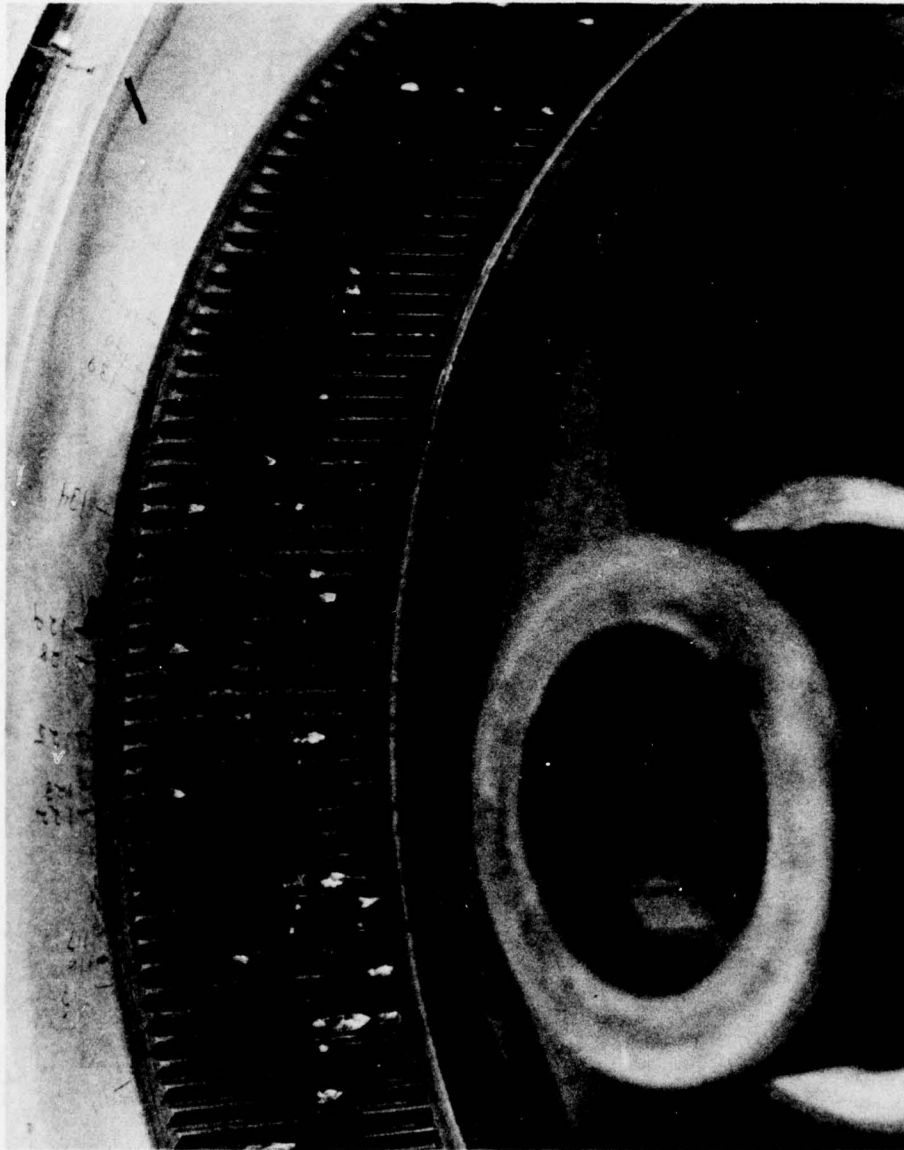
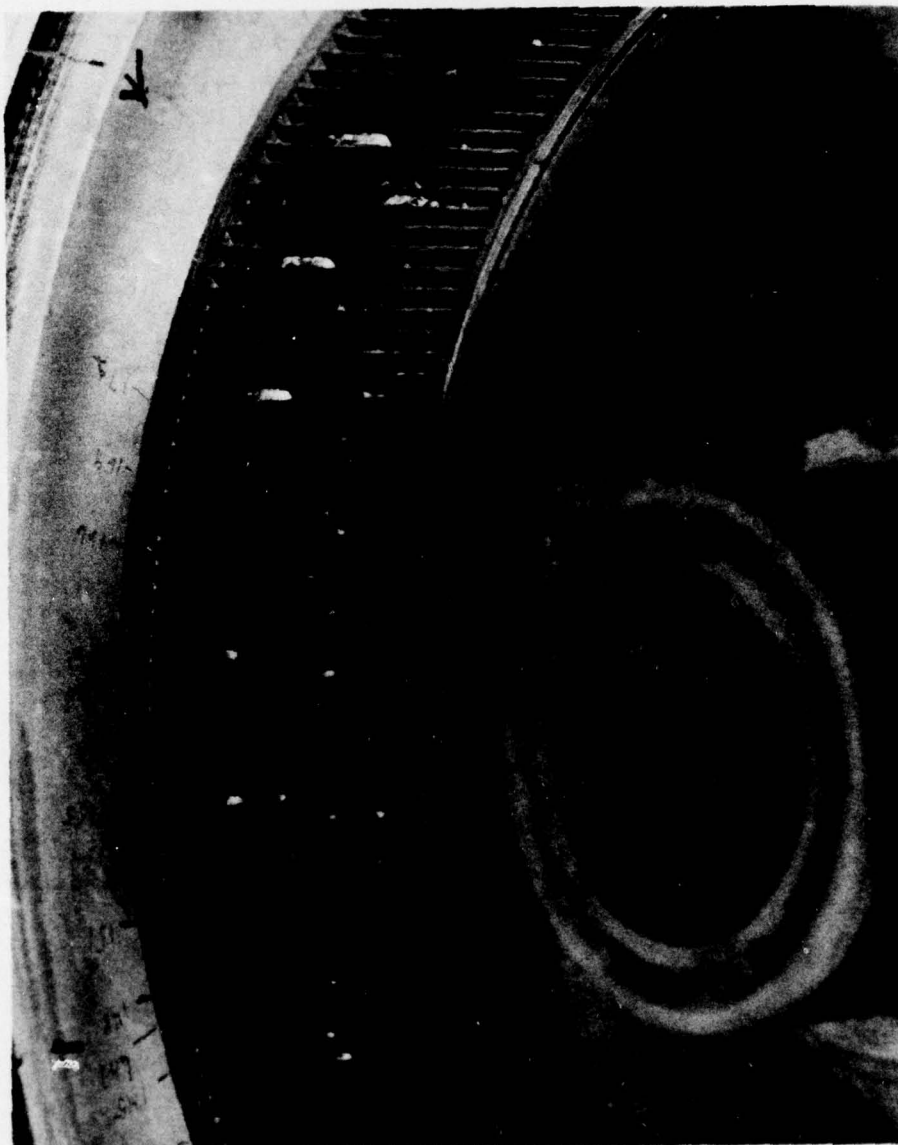
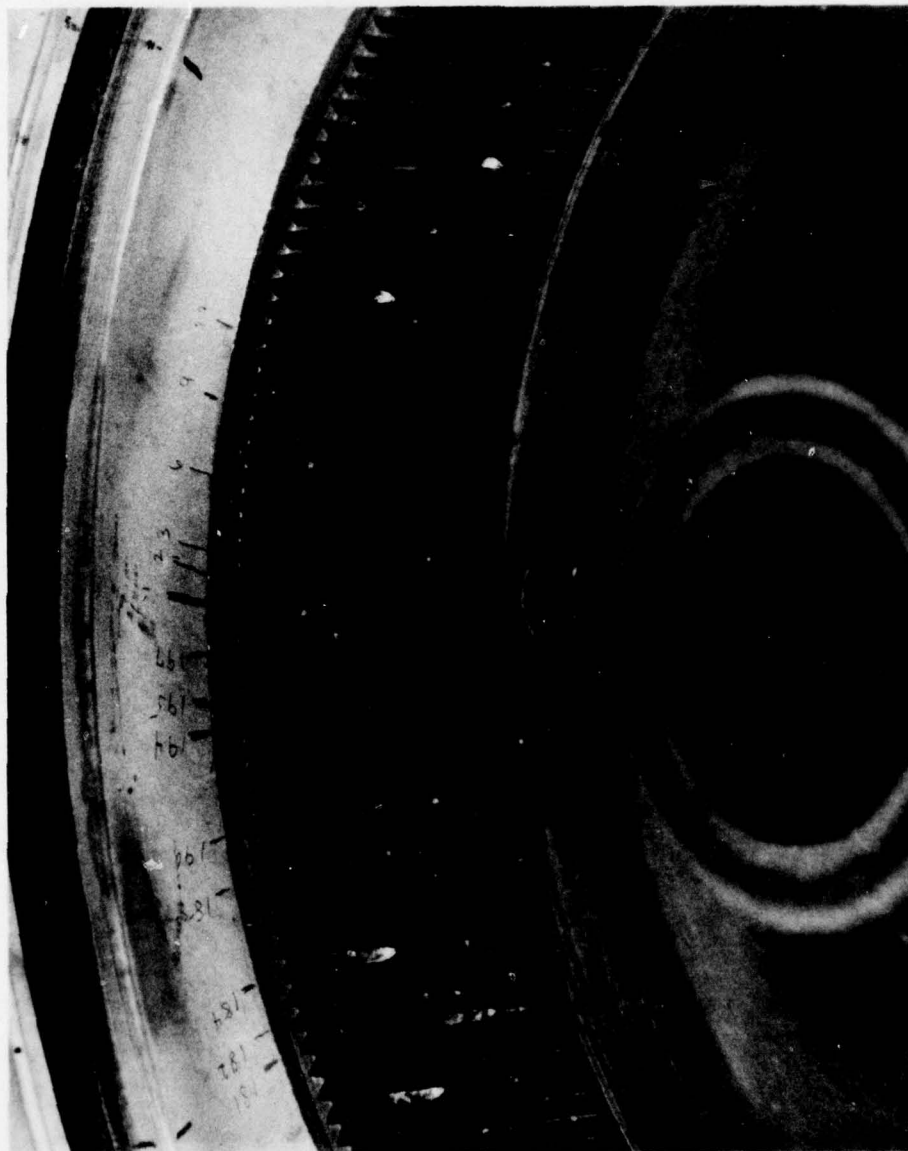
b. Lower ground gear, Bendix Part #2175525 - This gear had extensive damage to the gear teeth as shown in Figures 24 thru 28. As could be expected, the most damage occurred at the lower side of the gear where the damaged ring gear teeth meshed with this gear. This damage occurred at the lower side of the gear where the missing ring gear teeth meshes with this gear. This damage occurred for about one half of the gear's circumference. There are also some cracks on some of the remaining teeth which indicates failure was imminent. The numbers shown on the photos at the top of the teeth were used for denoting damage after run number 4. The damage that

occurred during run number 6 can be easily distinguished by comparing the photos of run number 4 (Figures 13 thru 16) with the photos (Figures 24 thru 28) of the gear after tests are completed.

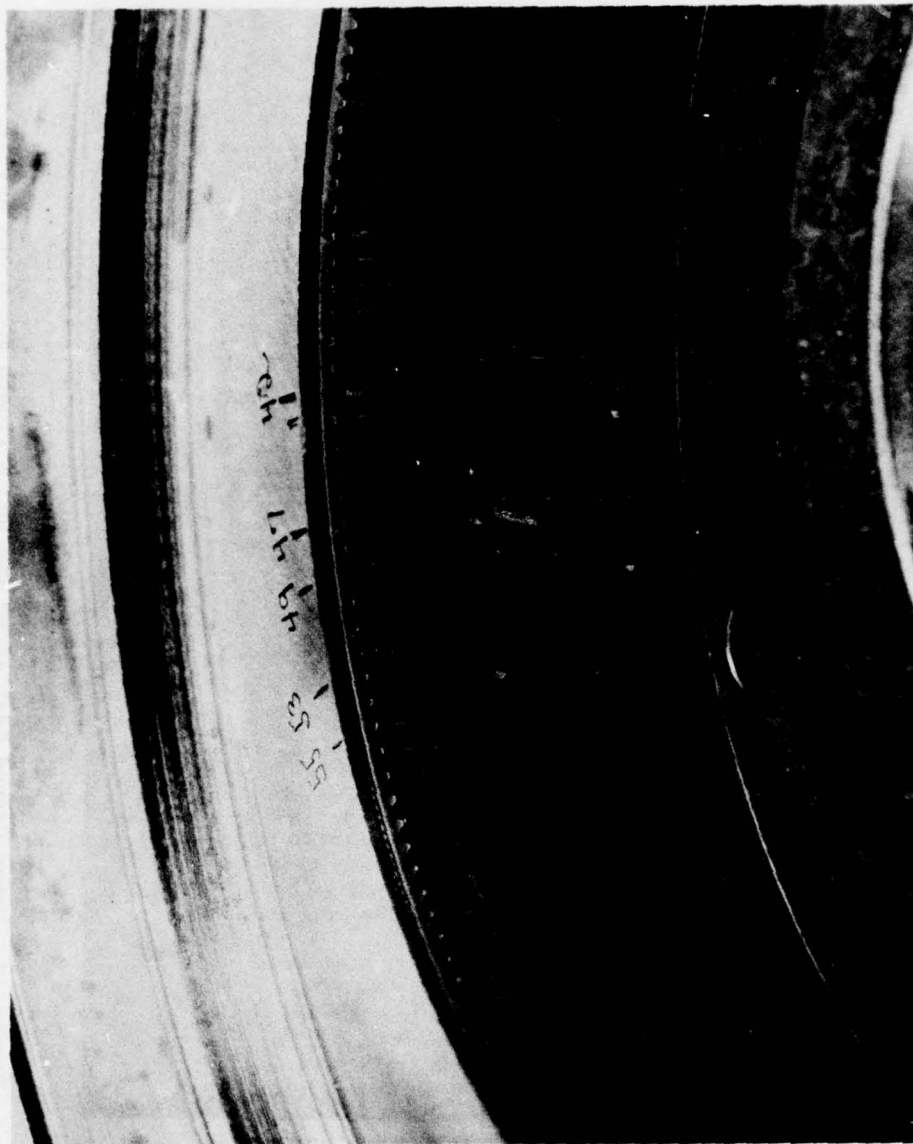
c. Upper ground gear, Bendix Part #2175526 - There was no additional damage or sign of wear found on this gear since the inspection after run number 3 as shown in Figures 29 thru 31. The previous photos of the same area of the gear are shown in Figures 17 and 18.

Figure 29. Upper Ground Gear After Run No. 6 (Teeth No. 42 Thru No. 55)

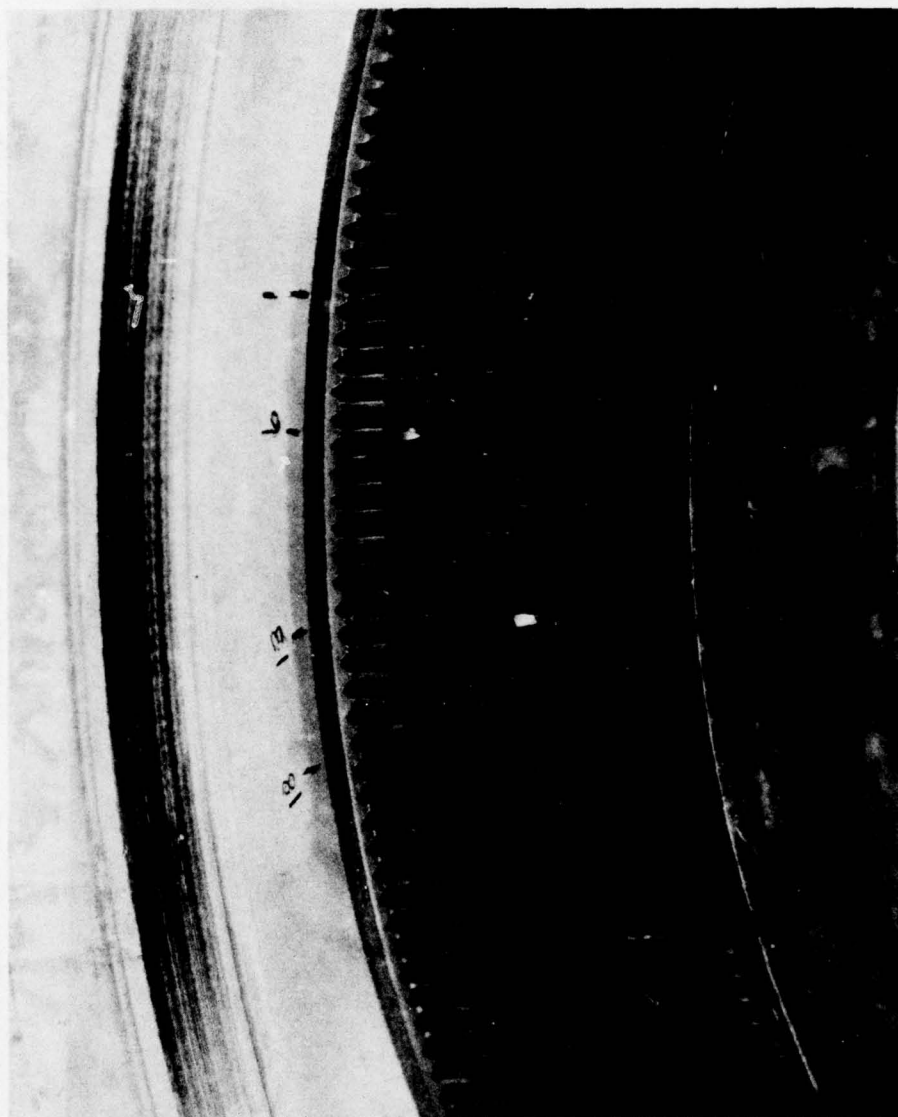
Figure 30. Upper Ground Gear After Run No. 6 (Teeth No. 6 and No. 13)
